FINAL REPORT
SMALL, HIGH-PRESSURE LIQUID HYDROGEN TURBOPUMP

A. Csomor and D. J. Warren

Rockwell International
Rocketdyne Division

NASA-Lewis Research Center
Contract NAS3-21008
R. E. Connelly, Project Manager

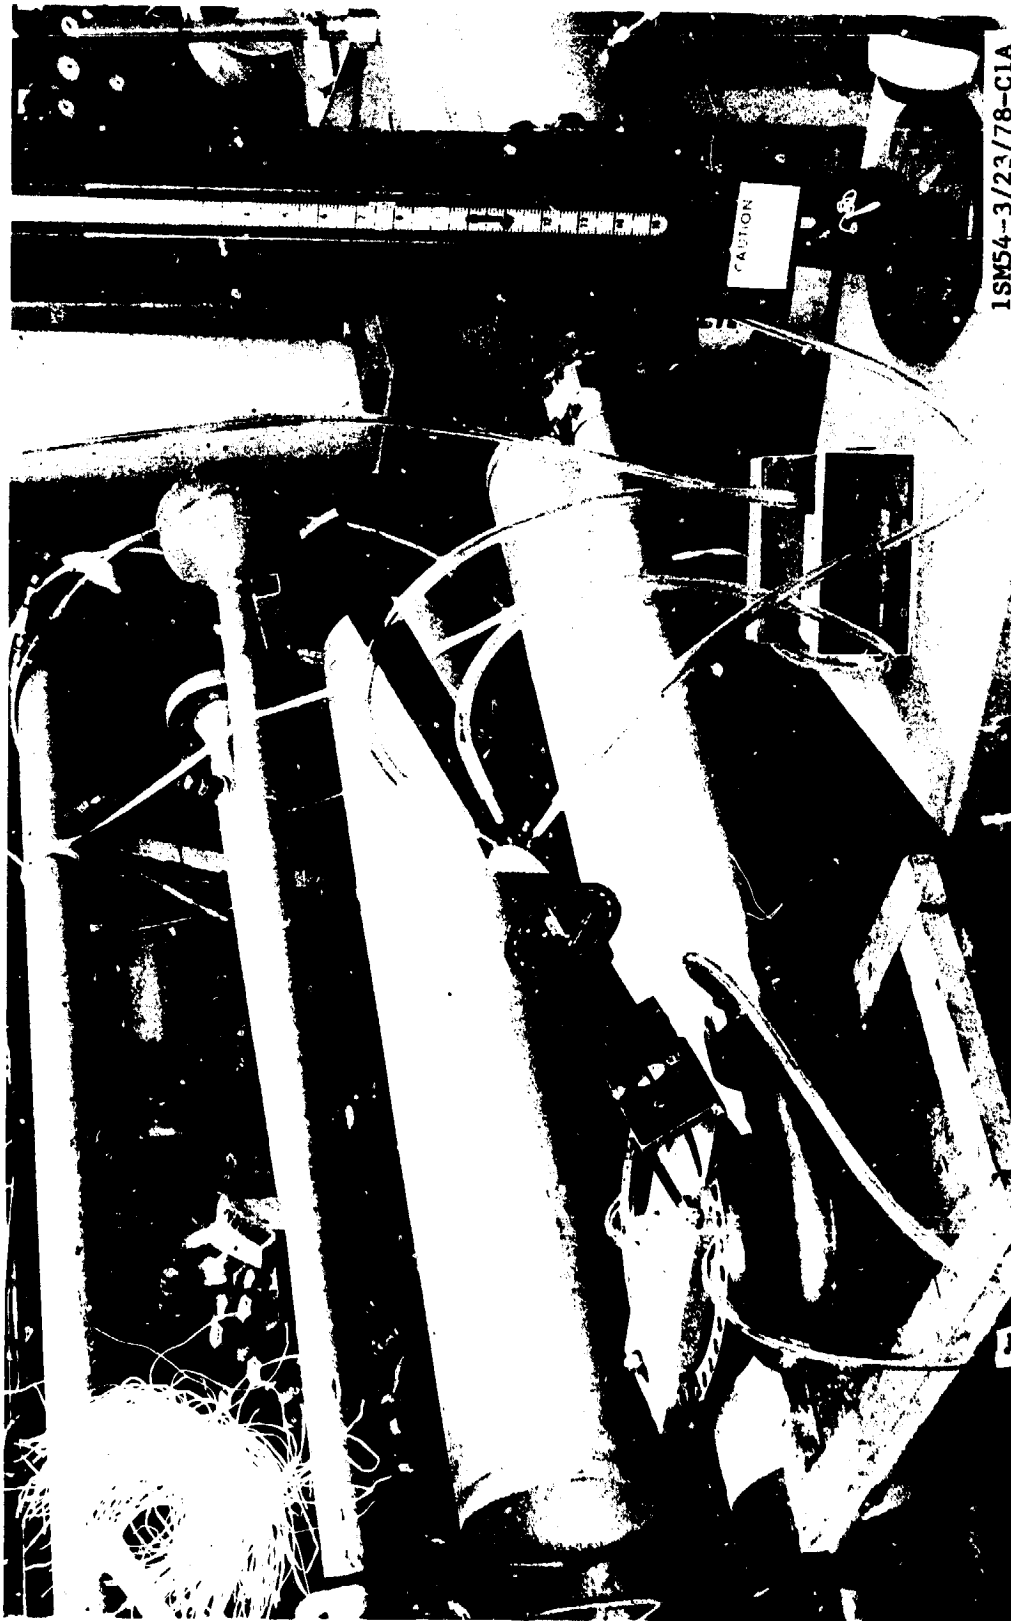
Figure 47. Mark 48-F Inlet Housing Air Flow
Test Installation (View 2)

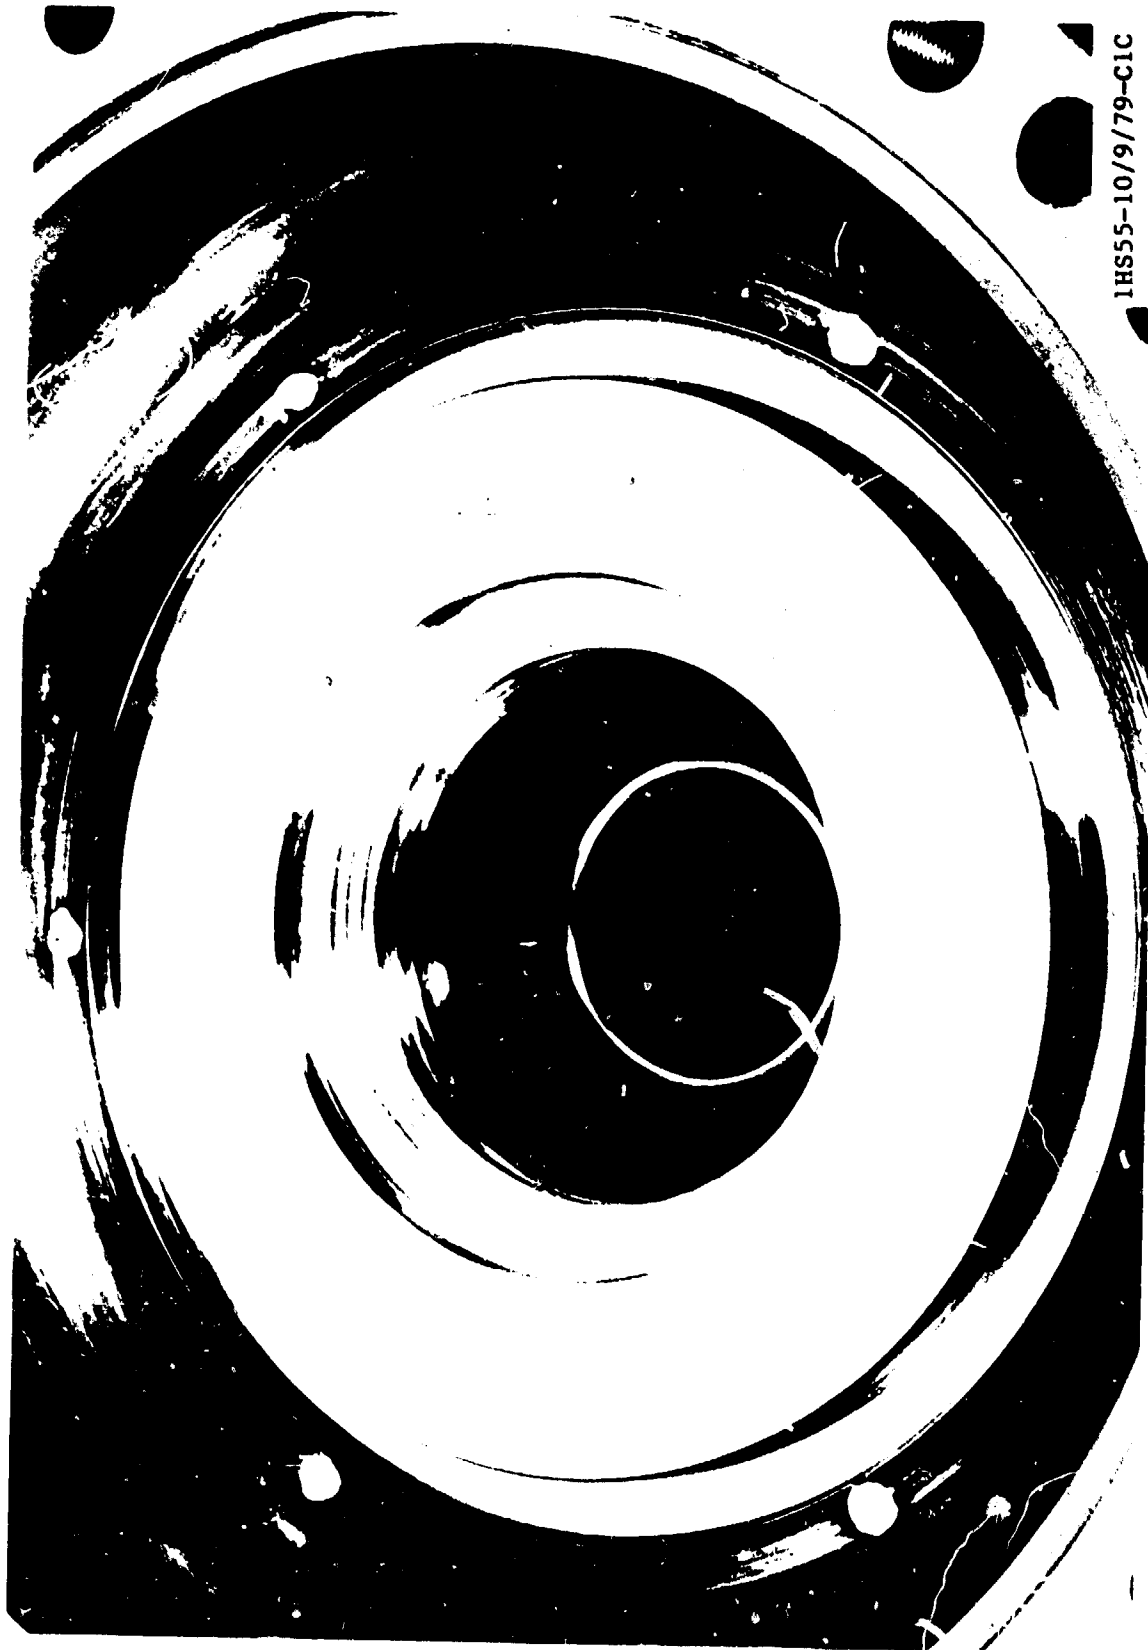
IHS55-10/9/79-C1C

Figure 144. Axial Inlet and First Stage Wear Ring

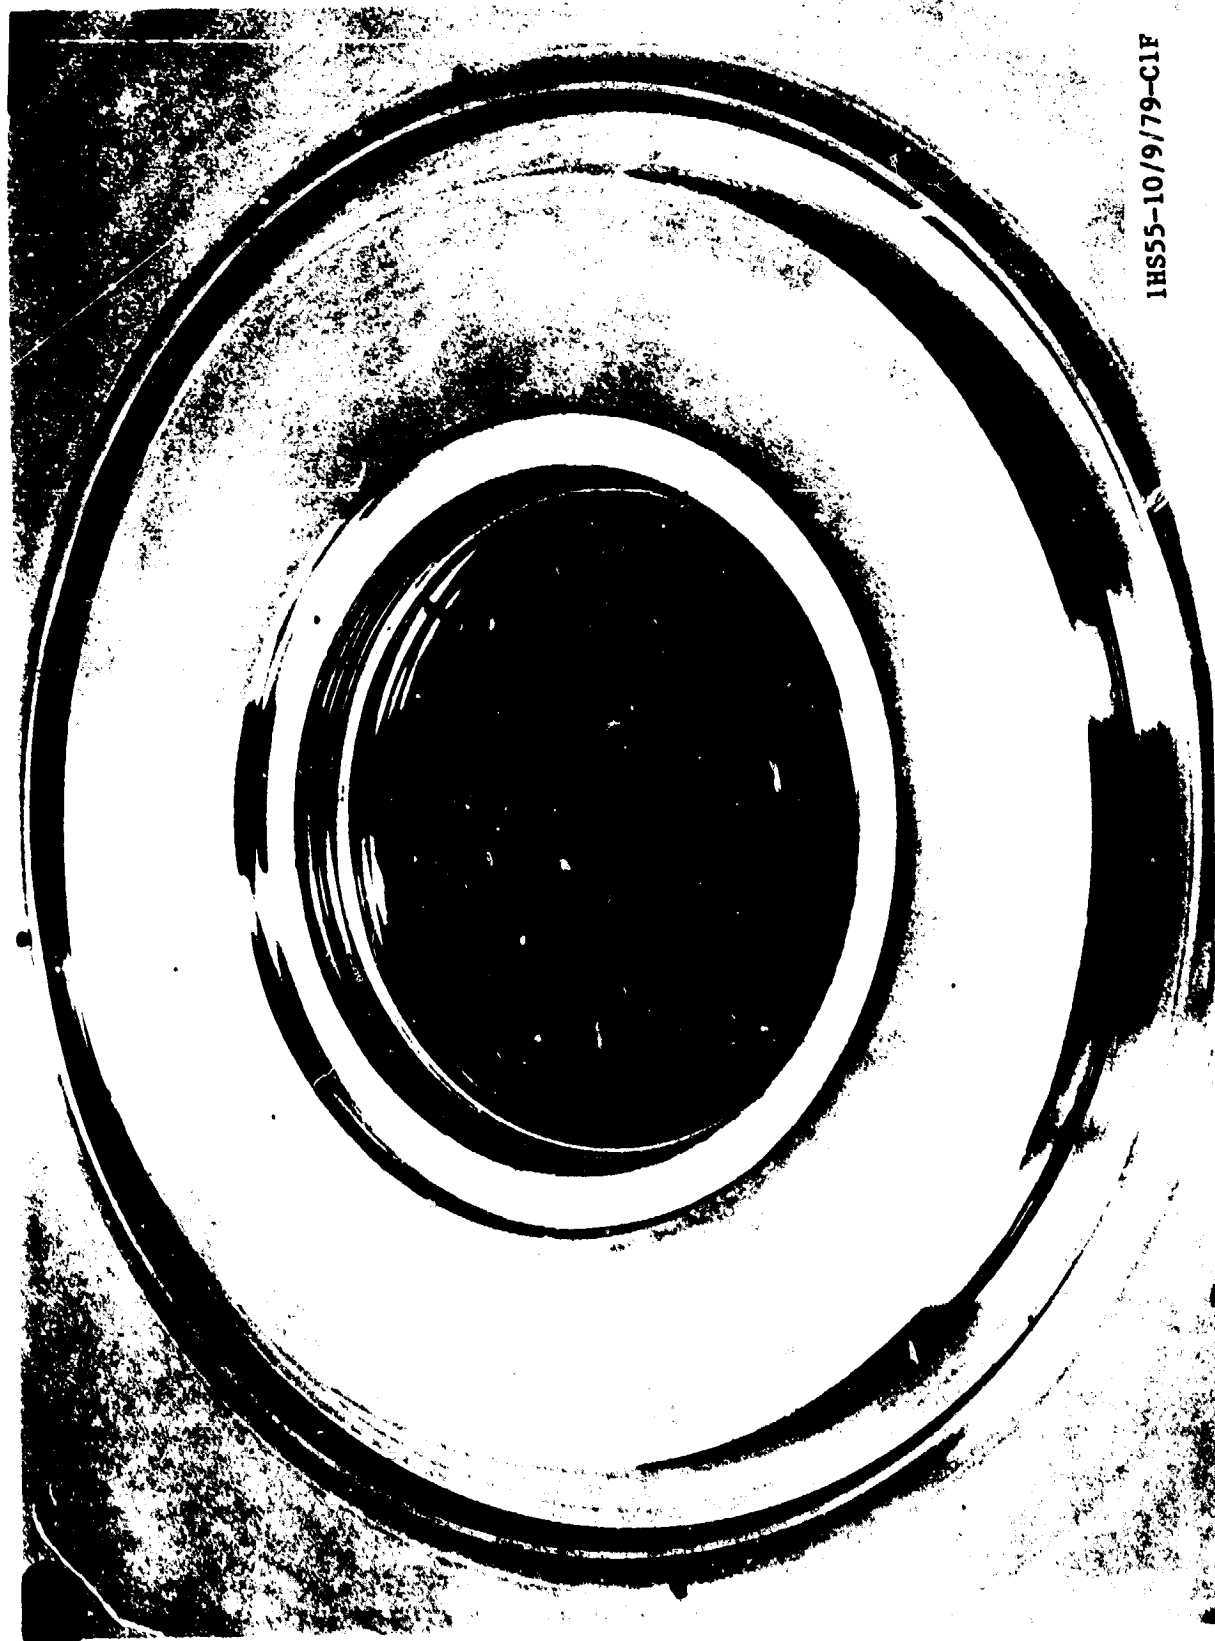
IHS55-10/9/79-CIF

Figure 145. First Stage Crossover and Second Stage Wear Ring

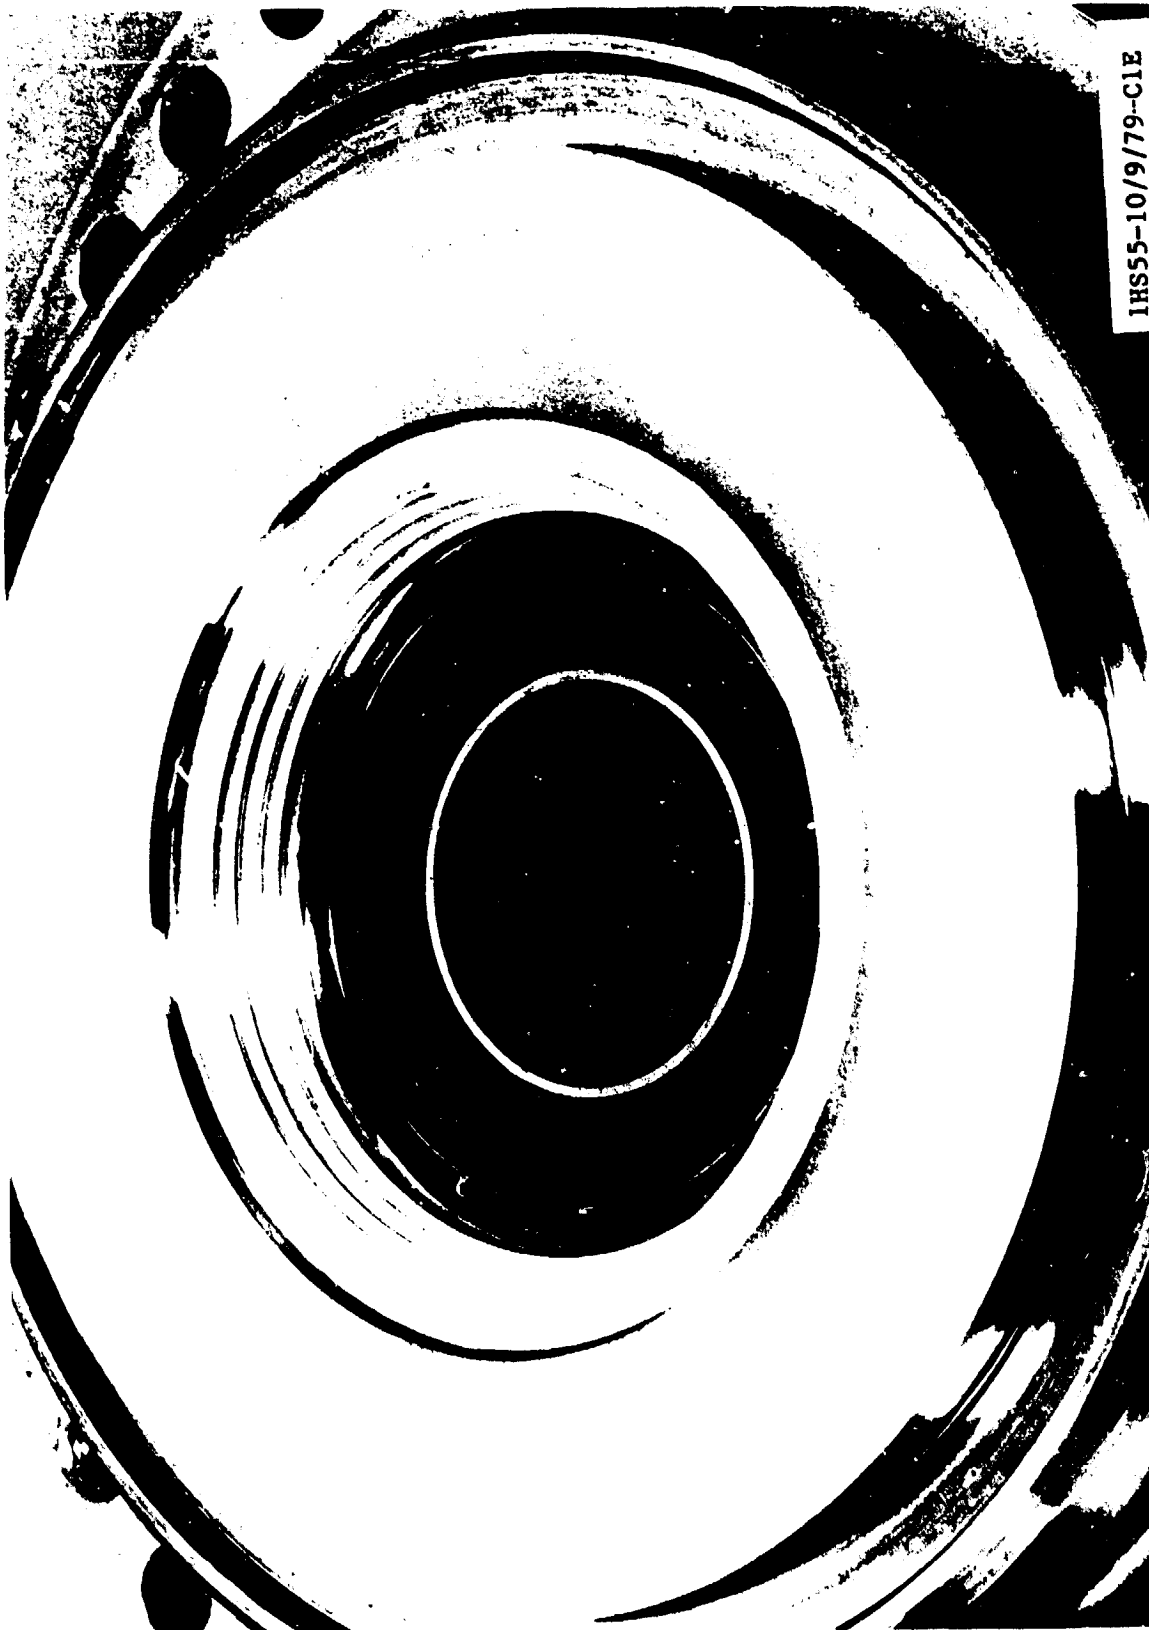
Figure 146. Second Stage Crossover and Third Stage Wear Ring

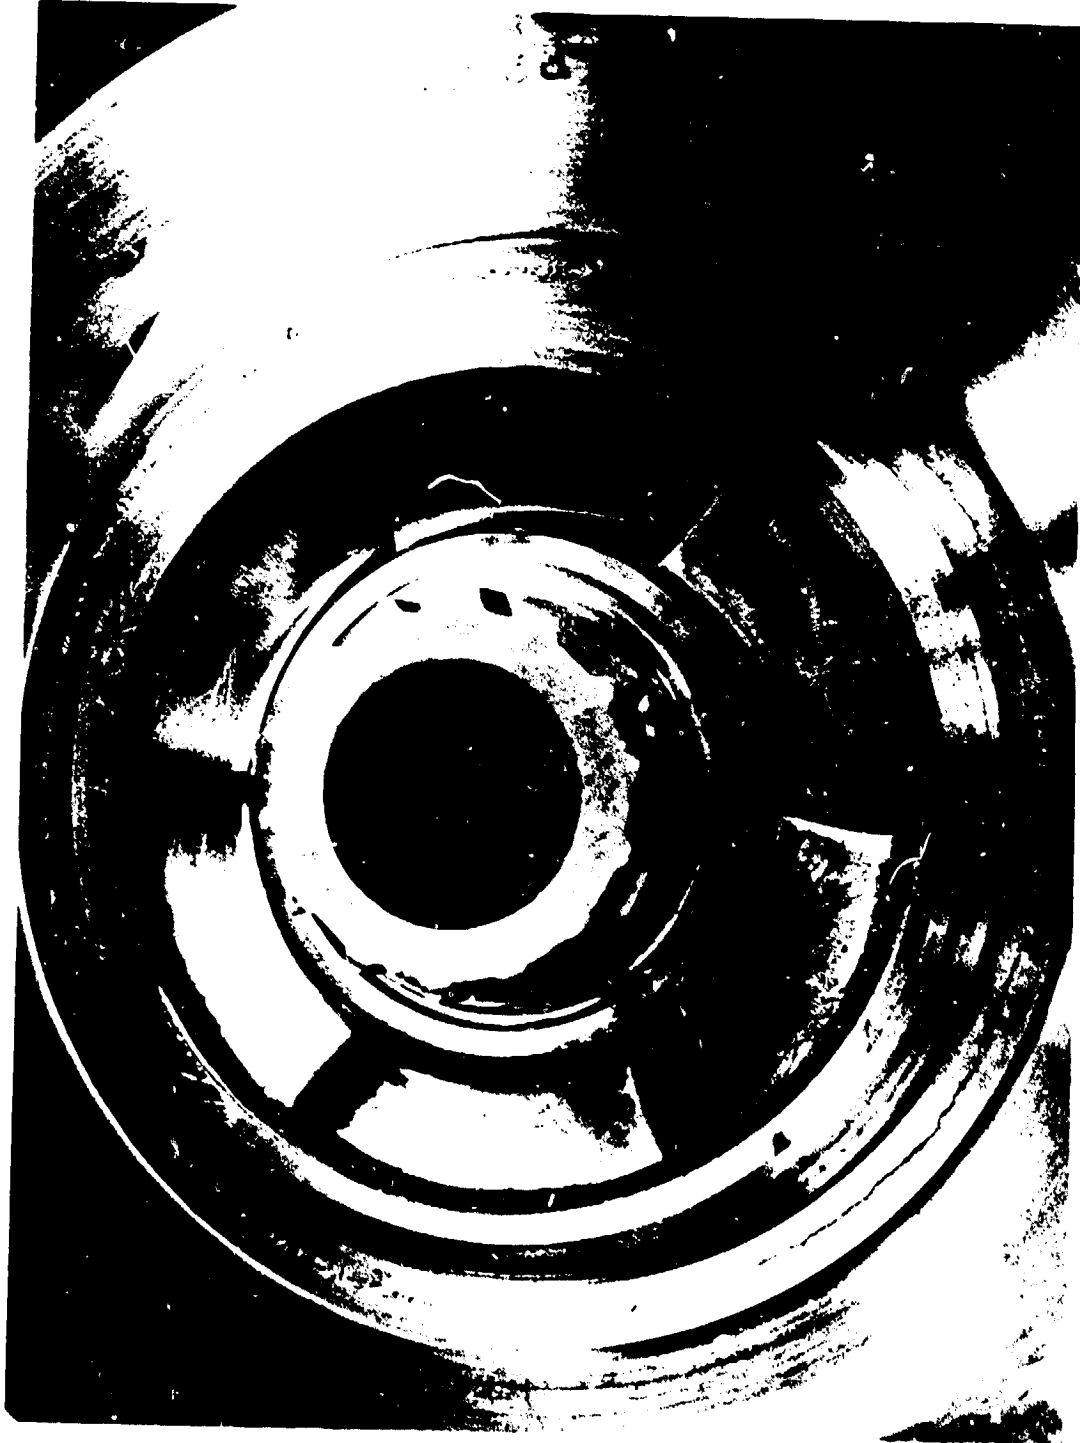
MK 48-F SECOND STAGE IMPELLER

The crack incurred in the second-stage impeller is shown in Fig. 147. A cross section of the impeller, illustrating the location of the electron beam weld joint is included in Fig. 148. Analysis with the aid of X-rays revealed that the electron-beam weld center was not located precisely on the interface between the two parts. As a result, the interface was fused only over part of the depth. The weld is not a structural joint from the standpoint of either detail needing it to sustain centrifugal loads. Its function is to prevent fluid recirculation and to provide a path to transmit torque from the main impeller hub to the preimpeller. Since there is sufficient radial interference at the hub between the two components to accomplish the latter function, the impeller could have continued to operate with possibly some increase in internal leakage. The impeller was not destroyed for the analysis; plans are to reweld the joint with a properly located electron beam weld pass, and continue to use it in future testing.

Figure 147. Crack In Second Stage Impeller Shroud

From the standpoint of mechanical integrity, the turbopump operated well. Disassembly of the unit disclosed a crack in a nonstructural weld in the second-stage impeller which was traced to a weld quality deficiency. All other components were found in excellent condition.
